**DESIGN, FABRICATION, AND STRUCTURAL EVALUATION OF  
AN ADVANCED COMPOSITE HYDROFOIL CONTROL FLAP**

by  
**William P. Couch**

**STRUCTURES DEPARTMENT  
TEST AND EVALUATION REPORT**

November 1982

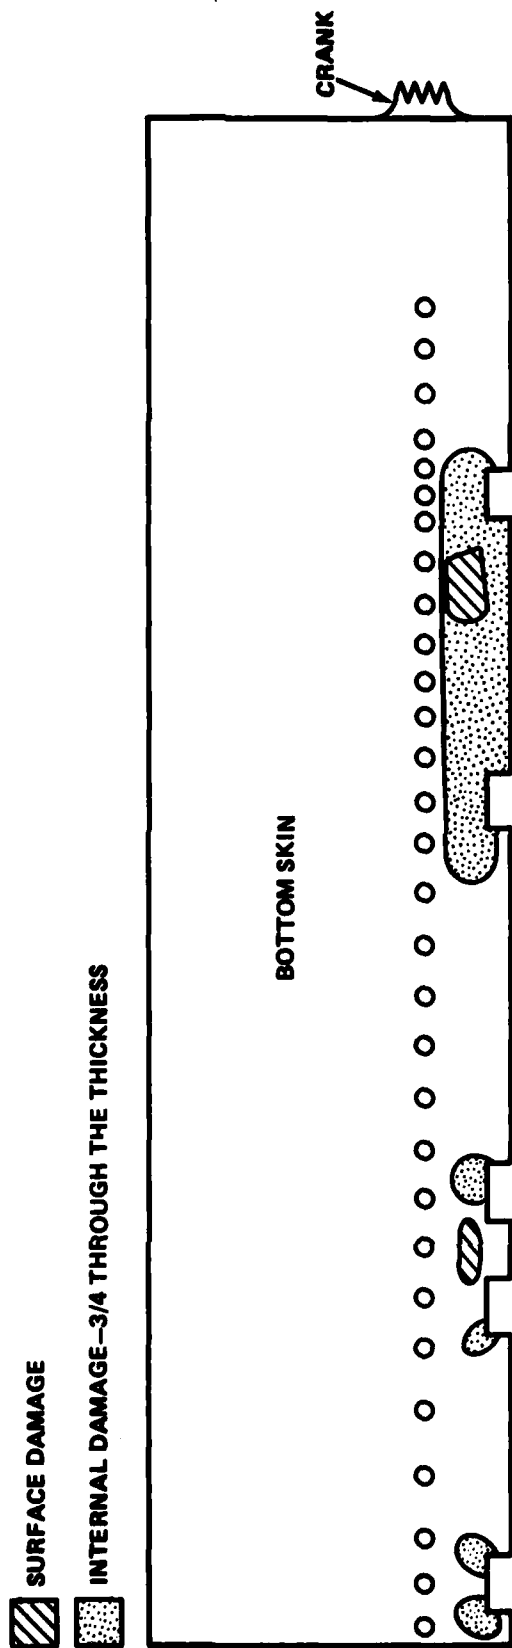
Figure 13 - Ultrasonic Inspection of Composite Flap after Static Overload

1. IN GENERAL, DAMAGE GREATEST IN HALF CLOSEST TO CRANK.
2. TOP SURFACE UNDEAMAGED.
3. UNABLE, WITH AVAILABLE TRANSDUCERS, TO EXAMINE CURVED LEADING EDGE.
4. DAMAGE CONFINED TO AREA BETWEEN CURVED LEADING EDGE AND FIRST ROW OF BOLTS ON BOTTOM SURFACE.
5. TWO HINGES FARTHEST FROM CRANK-DAMAGE AT CORNERS ONLY.
6. SLIGHT SURFACE DAMAGE AROUND BOLTS BETWEEN FOURTH AND FIFTH HINGES.
7. DAMAGE BETWEEN THIRD AND FOURTH HINGES - SURFACE AND POSSIBLY INTERNAL DAMAGE EXTENDS ONE-HALF WAY FROM HINGES TO BOLTS.
8. CLOSER TO CRANK END, DAMAGE EXTENDS ALL THE WAY TO THE ROW OF BOLTS.
